ROYAL AUSTRALIAN AIR FORCE

AIRCRAFT RESEARCH AND DEVELOPMENT UNIT

TECHNICAL INVESTIGATION NO 778

EVALUATION OF NEW IROQUOIS TORQUEMETER PN 73-30-1

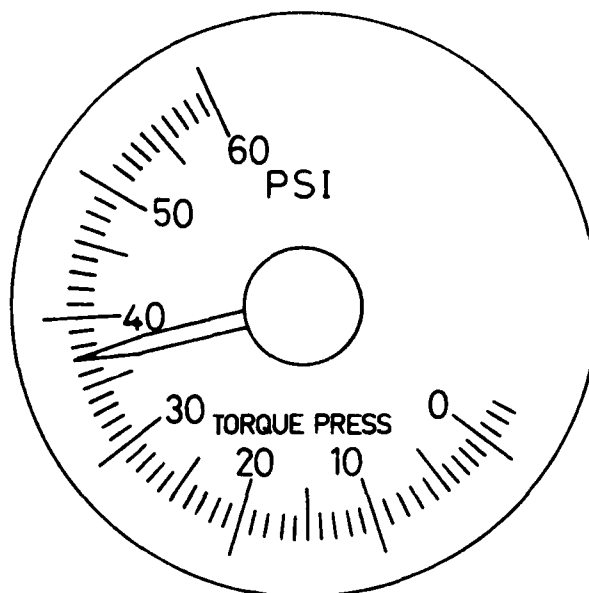
FIGURE 3.2 - MODIFIED GRADATION MARKS AND POINTER

3.7.2 Scale Obscuration. The needle and all instrument face markings were fully in view from the pilot's seat. From the co-pilot's seat, the outer sections of the scale markings were obscured by the instrument bezel in the range 30 psi to 55 psi. Markings greater than 55 psi were completely obscured by the top left instrument post light. Confined area operations often demand that the pilot's attention is directed outside the helicopter to maintain clearances from obstructions during approaches and departures. The co-pilot is required to monitor engine performance (primarily torque) and clearances on the left side of the aircraft. Obscuration of torquemeter markings in the range greater than 30 psi could cause misreadings. Alternatively, the co-pilot may compensate for this deficiency by leaning to the right so that all markings are visible. This would detract from his secondary task of monitoring clearances on the left side of the aircraft. Obscuration of instrument markings in the range greater than 30 psi, as viewed from the co-pilot's seat, was unsatisfactory. This may be overcome by pilot compensation or alternatively by adopting the modifications recommended in Paragraph 3.7.3.

3.7.3 Pointer and Gradation Marks. The following modifications to the pointer and gradation marks are recommended to help alleviate deficiencies outlined in Paragraphs 3.7.1 and 3.7.2:

- a. Incremental 5 psi Marks. The gradation marks at increments of 5 psi should be extended inwards instead of outwards. This would help compensate for the obscuration of the markings when viewed from the co-pilot's seat.
- b. Pointer Taper and Length. The pointer should be more finely tapered (eg similar to the EGT indicator pointer) and extended slightly so that the tip reaches approximately the middle of the gradation marks. This would help to reduce parallax errors.

A sketch of the indicator face, incorporating the proposed modifications, is shown in Figure 3.2.

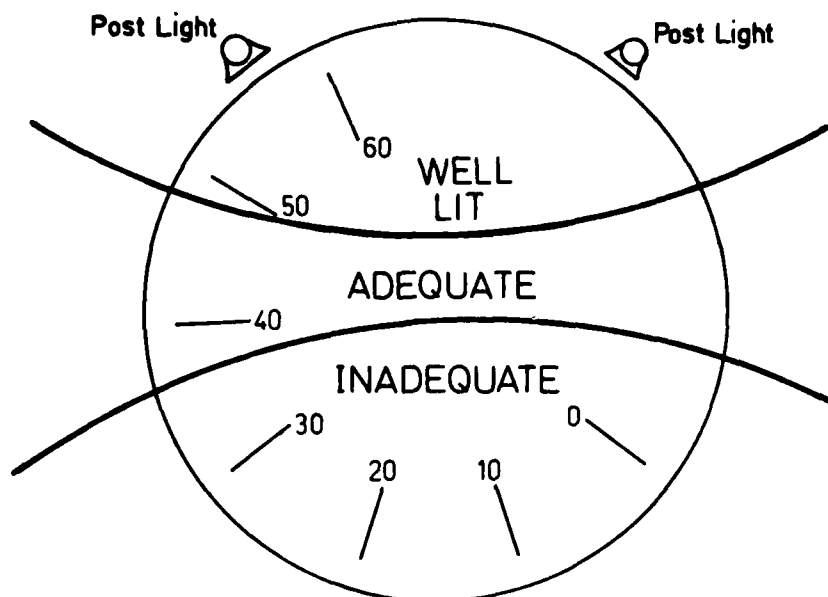
FIGURE 3.3 - LIGHTING LEVELS

3.7.5 Lighting. The instrument was lit by two red filtered post lights mounted above the instrument at the approximate relative positions of eleven and one o'clock. Instrument lighting was assessed at night with the lighting intensity adjusted to approximately mid-range (representative of the selection made by most pilots for night operations). Figure 3.3 illustrates the light dispersion pattern which resulted. The post light at the one o'clock position virtually provided no illumination of the scale area and served no useful purpose. The red-painted gradation mark at 50 psi blended with the other gradation marks and was difficult to discern from other markings. Inadequate lighting of the scale from zero psi to approximately 35 psi will cause difficulty in reading engine torque during cruise flight and descent when conducting night operations. The night-lighting of the instrument was unsatisfactory and should be corrected to improve lighting in the zero to 35 psi area. Failure to correct this deficiency may force use of higher than necessary overall lighting levels to accommodate the inability to see this area of the instrument.

4.4 The night-lighting of the instrument was unsatisfactory (Paragraph 3.7.5). This deficiency could be overcome by pilot compensation; however, the night-lighting should be improved.

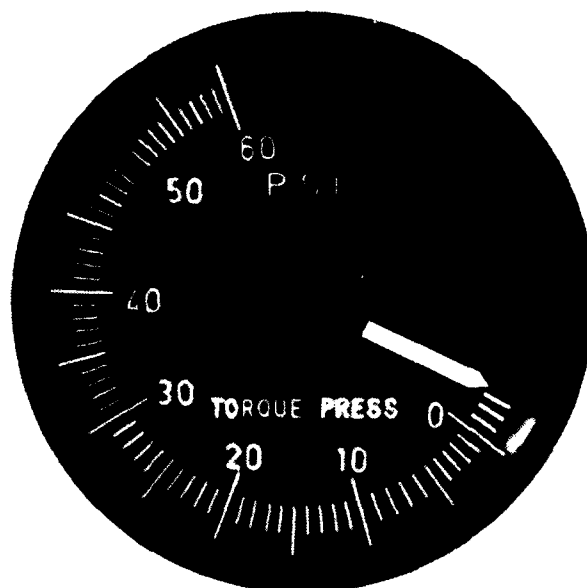
FIGURE 1 - FACE OF TORQUEMETER PN 73-30-1

3.7.4 Reflections. The face of the instrument was covered by plain glass. Reflections on the glass made the instrument difficult to read under some conditions. Also, reflections of red and orange coloured objects (eg helmet tape, Life Vests Mk 8) occasionally were misinterpreted by the pilot as activations of warning or caution lights when the instrument was in his peripheral vision. Although many other of the instruments on the panel have plain glass covers which also produce many reflections, there is no reason to perpetuate the deficiency. The reflection characteristics of the torquemeter glass cover were undesirable. The cover should be replaced with an appropriate form of non-reflective glass.

5.6 The instrument face glass cover should be replaced with an appropriate form of non-reflecting glass (Paragraph 3.7.4).
